"Let Us Inspect Before You Invest"
PHONE 954-817-5537

STRUCTURE TYPE:

2007 S.W. Idaho Lane Port Saint Lucie, FL 34993

Single Family Residence

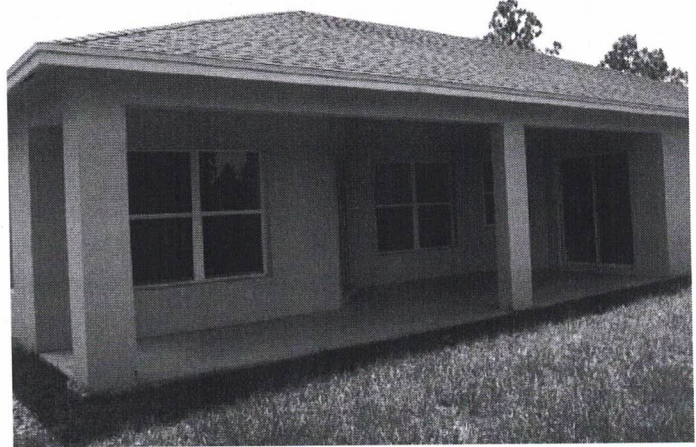
A-12-01 The stucco cladding around the windows were observed with more then normal cracking, and splits. These areas will need to be repaired and sealed properly to prevent moisture intrusions to the interior walls. It should be noted that this inspector did check the interior areas of the windows and the walls, and these areas were found to be dry at the time if inspection. (Refer to Photos) **ESTIMATE \$ 150.00**

MISSING EXTERIOR STUCCO CLADDING
